Nuclear Cryogenic Propulsion Stage (NCPS) Fuel Element Testing in the Nuclear Thermal Rocket Element Environmental Simulator (NTREES)

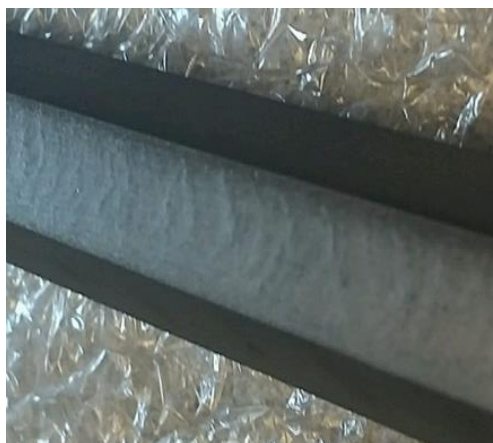
Figure 4 Testing Shows No Visible Damage

During the testing, the fuel element behaved as expected indicating that it likely survived the nominal testing conditions intact thus meeting all the predetermined project objectives. After the test concluded, the NTREES test chamber was depressurized and the fuel element allowed to cool to room temperature. The NTREES test chamber was then opened up and the fuel element removed. A visual inspection of the fuel element confirmed that no damage had occurred to the fuel element thus satisfying testing milestone required by the NCPS project. Figure 4 illustrates the condition of the fuel element after the test was completed. Note that the surface shows no obvious signs of damage.

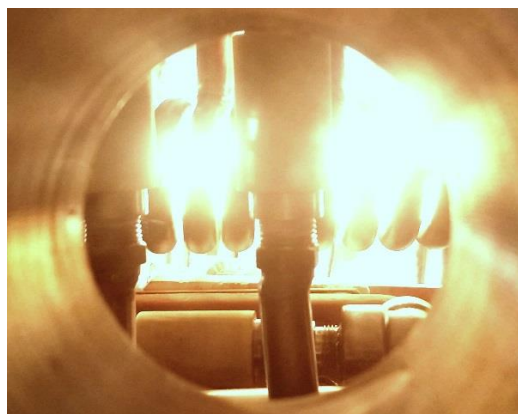
Figure 5 Fuel Element at Maximum Power

During this testing, the fuel element was above 2800 K for almost 4.5 minutes and was above 2500 K for over 8.5 minutes. The 2800 K temperature in the fuel element was achieved at an induction power level of approximately 169 kW or at just over 14% of the power available from the 1.2 MW induction heating unit. It was noticed near the end of the 4.5 minutes the fuel element was at 2800 K, that the temperature in the fuel element was starting rapidly fluctuate over a several hundred degree range and

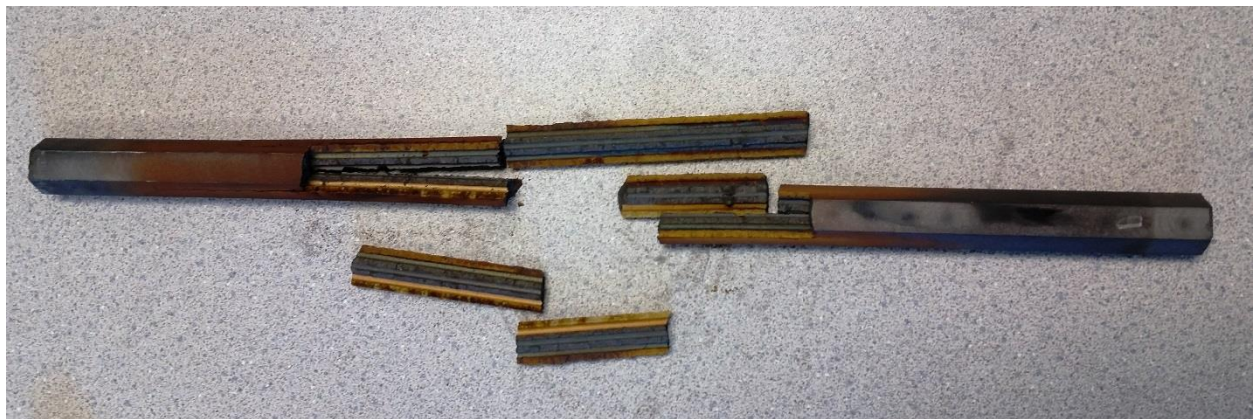
Figure 6. Failed Fuel Element from NTREES Test at 2800 K

generally decrease in magnitude. Simultaneously, the induction power in the induction heating unit started to increase slightly. This type of behavior indicated that fuel element damage was probably beginning to occur. The decision was then made to slowly decrease the induction power in the NTREES induction heater so as to slowly drop the temperature in the fuel element. After about 11 minutes, the induction power level had been reduced to approximately 30 kW and the temperature in the fuel element had been reduced to roughly 1000 K. At this point, the hydrogen concentration level in the chamber spiked significantly resulting in an automatic system shutdown wherein the induction power was cutoff and the main hydrogen inlet valves were closed. System purging with nitrogen was also initiated as a result of the shutdown. The cause of the hydrogen concentration spike was thought to almost certainly be due to the catastrophic failure of the fuel element. Such a failure would cause the hydrogen normally flowing through the fuel element to discharge directly into the NTREES chamber rather than into the hydrogen/nitrogen mixer assembly as would be the case if the fuel element were still intact. Upon removal of the fuel element from the chamber, it was indeed confirmed that the fuel element had failed catastrophically as shown in the post test photograph illustrated in Figure 6. It should be emphasized that the conditions under which the fuel element failed were well in excess of those at which fuel failure was expected to occur and demonstrated considerable robustness in a very preliminary fuel element configuration.

NTREES itself apparently suffered no damage as a result of the fuel failure. The induction coil showed no degradation from the fuel failure and even the insulating sleeve which surrounded the fuel element during the test survived intact. There was a noticeable smell near the chamber after the test which was probably due to heating in the G10 feedthru flange as a result of the high current going through the conductor plates. Other than the smell, however, there did not appear to be any damage to the flange.
